Phase I Environmental Site Assessment

ISSAQUAH SCHOOL DISTRICT PROPERTY

Issaquah, Washington

Project No. 20180070V002

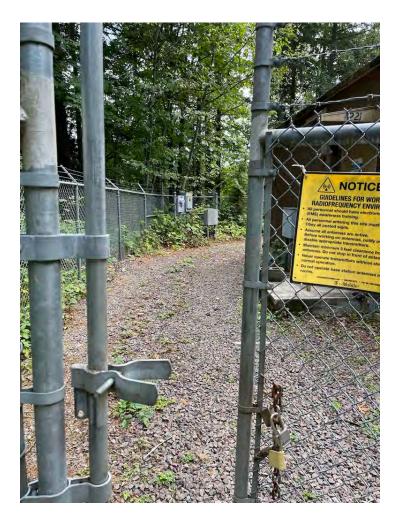
Looking southeast at the former water tower that is now a cellular tower in the southeast portion of the Subject Property. The perimeter gate was not secured. One of the two buildings was locked. The other appeared to be occupied based on rustling noises heard as the investigator approached.

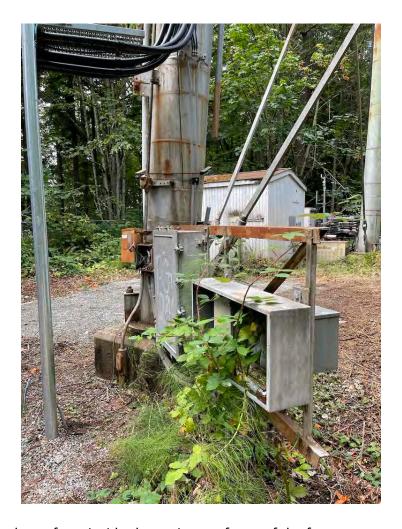
Looking south and east from inside the perimeter fence of the former water tower at the the southeastern building at the base of the water tower in the southwest portion of the Subject Property. No soil staining was observed.

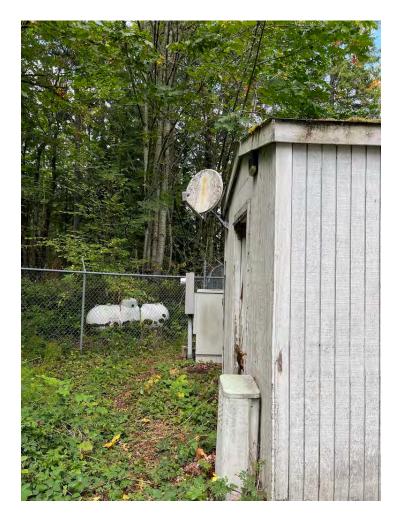
Aboveground apparently former Propane Storage Tank from the damage adjacent to the southeastern building outside of the perimeter fence.

One propane aboveground storage tank (AST) was observed adjacent to the perimeter fence around the former water tower. Its status is apparently inactive due to the damage observed (Attachment 1). There were no signs of USTs, even in the area where the 500-gallon heating oil UST was removed and decommissioned in June 2007 (Sound Environmental Strategies [SES], 2007). No significant staining, adverse odors, stressed vegetation, or any other indications of improper use, storage, or disposal of hazardous materials were noted.

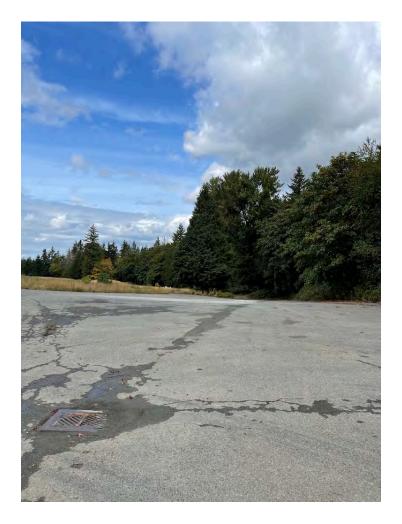
Looking north at the northwestern parcel of the Subject Property. A storm drain is in the foreground. It was clear and showed no petroleum sheen.

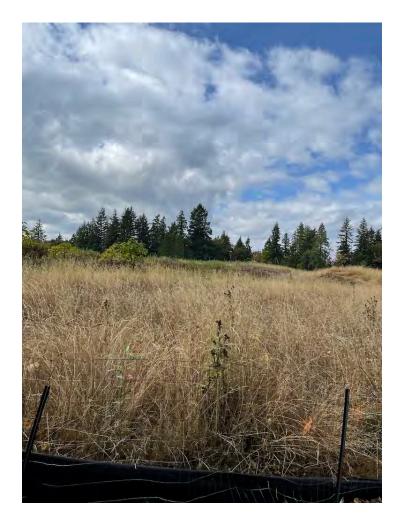
Looking northeast at the northeastern portion of the former Trinity Lutheran College Campus and the trees that line it.

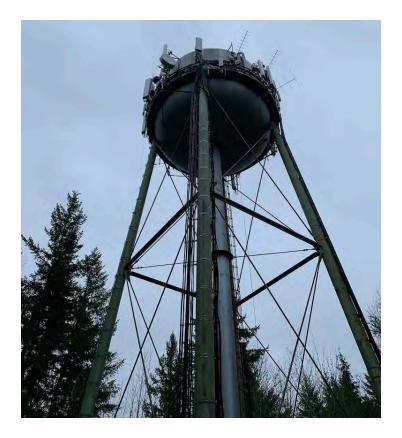
3. FACING SOUTH AT THE FORMER WATER TOWER THAT IS NOW A CELLULAR TOWER IN THE SOUTHEAST PORTION OF THE SUBJECT PROPERTY.

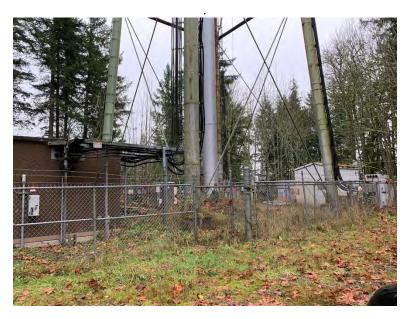
4. FACING SOUTH AT THE LOCKED FENCE AND TWO SMALL BUILDINGS AT THE BASE OF THE WATER TOWER IN THE SOUTHEASTERN PORTION OF THE SUBJECT PROPERTY.

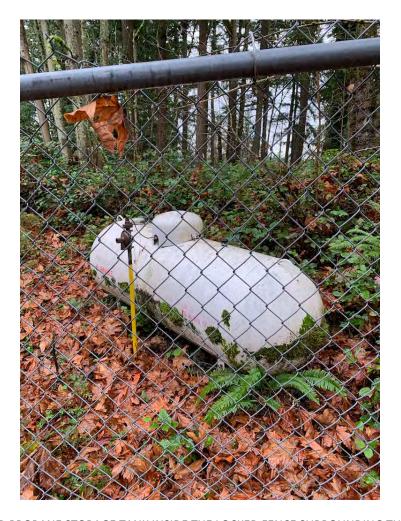
5. ABOVEGROUND PROPANE STORAGE TANK INSIDE THE LOCKED FENCE SURROUNDING THE WATER TOWER.

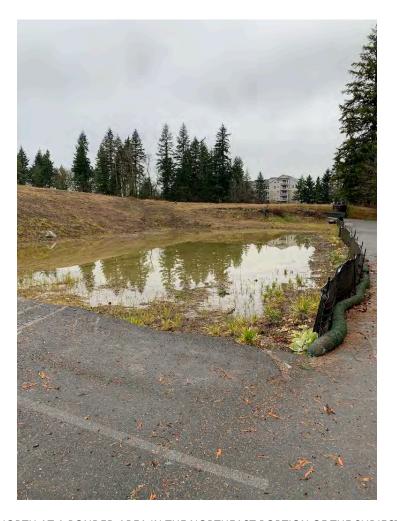
11. FACING NORTH AT A PONDED AREA IN THE NORTHEAST PORTION OF THE SUBJECT PROPERTY.
